Manhole Inspection Summary

Manhole # S45E2_045MH

Insp Date: **12/17/07 11:40 AM**

Location Address: **Inner Circle**

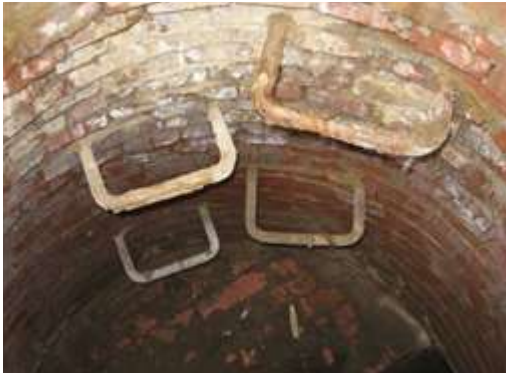
Steps Count: **4** Missing: **0** ☐ Corroded

Steps

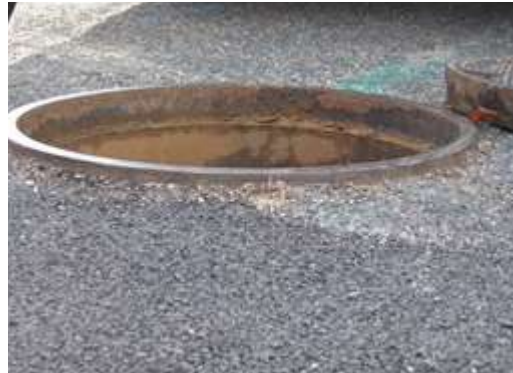
Defect 2

Cover Shape: **Circular** Diameter: **24** (in.) Length: (in.) Dist A/B Grade: **1** (in.)

Above grade

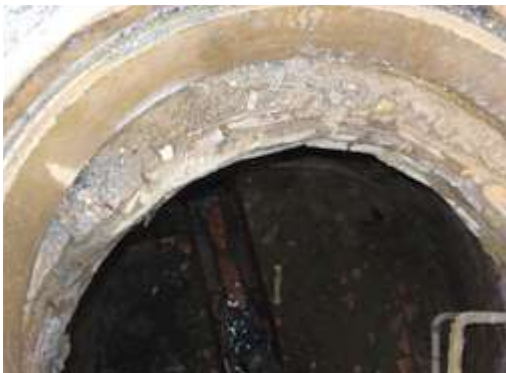
Defect 1

Frame Offset: **3** (in.) Condition: ☒ Sound ☐ Cracked ☐ Leaks

Frame offset

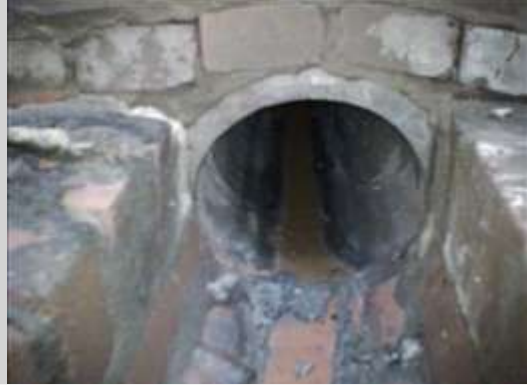
12 O'Clock Outflow

8 in. Circular Gravity Sewer
Pipe Out @ 12 O'Clock

Pipe Height: **8.4** (in.) Rod and Bar (Angled)

Pipe Material: **Clay** ☐ Pipe Lined

Invert Depth: **7.92** (ft.) Flow Characteristics: **None**

Infiltration: **None** Pipe Seal Cond: **Sound**

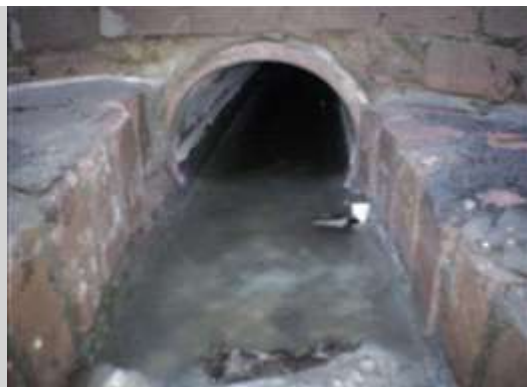
6 O'Clock Inflow

8 in. Circular Gravity Sewer
Pipe In @ 6 O'Clock

Pipe Height: **8.4** (in.) Rod and Bar (Angled)

Pipe Material: **Clay** ☐ Pipe Lined

Invert Depth: **7.63** (ft.) Flow Characteristics: **None**

Infiltration: **None** Pipe Seal Cond: **Sound**
